## Irregular wireless multicast delivery causing poor audio experience

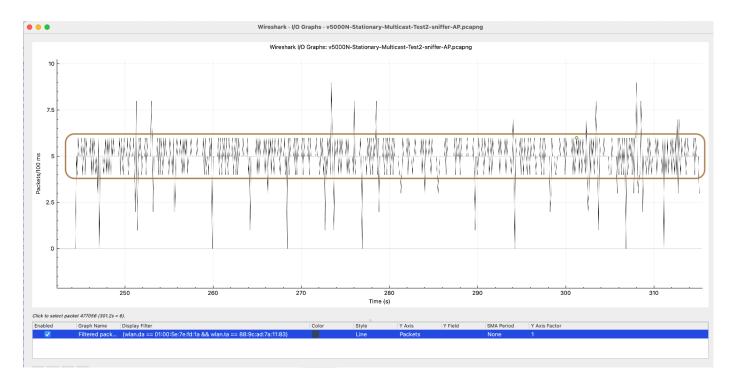
Wireshark I/O Graphs were used to analyze audio stream latency and jitter. Downstream multicast from the AP was graphed over time using an interval (sampling period) of 100ms. Our badges use the G.711 audio codec which sends an RTP frame every 20ms. With an interval of 100ms we would expect to see approximately 5 audio frames for every point on the graph. An ideal stream presents itself as a zig-zag pattern alternating between 4 and 6. This is outlined in green below. All of the outliers, specifically the drops to 0 packets per 100ms, were especially concerning.

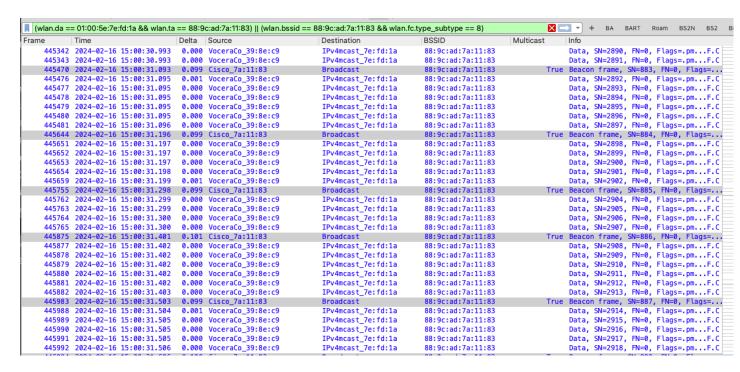
Looking closer at these instances of jitter I noticed there was a change in how the AP was delivering the multicast to the BSS. Most downstream multicast frames were sent using 802.11 standard multicast delivery at the DTIM. With a DTIM of 1, we see 4-6 frames being delivered immediately after each beacon – every ~100ms. See below.

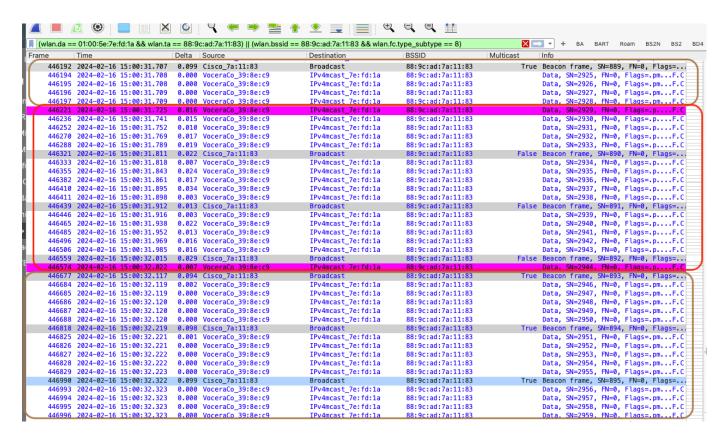
However, at the times of the jitter, the AP was switching to multicast delivery in real-time, i.e. close to 1 frame per 20ms. Moreover, the beacons were also announcing to the BSS that no multicast frames were buffered for clients, i.e. Multicast bit of the Bitmap control within the TIM Information Element was set to '0'. A column was added to show this as T/F.

This was brought to the wireless vendor who subsequently identified a bug. Cisco Multicast Direct with Media Streams was implemented to resolve the issue. This is Cisco's

implementation of multicast to unicast conversation over 802.11. Proper multicast to unicast behavior was verified via packet capture.

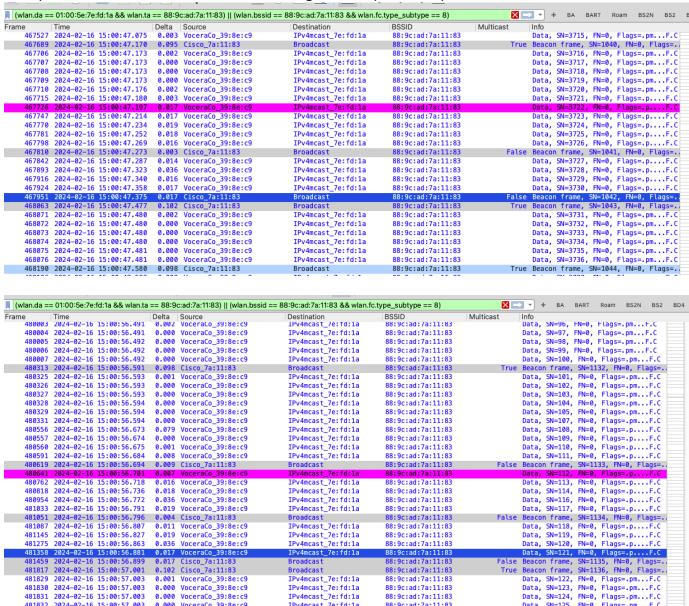
Multiple instances of this would found throughout the packet capture.
